Section 7 – West Branch of the Delaware River Stream Segments and Management Units
 January 10, 2005

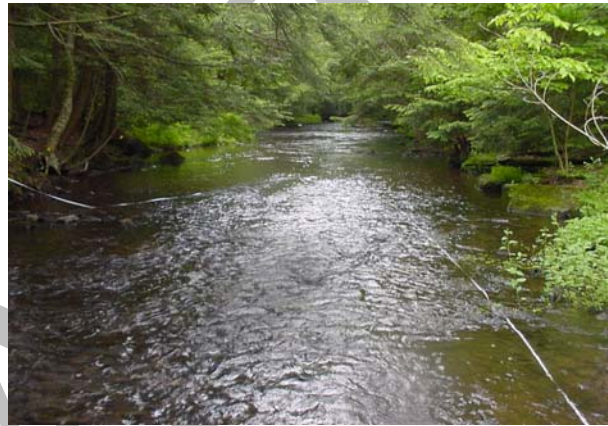
Management Unit 1 is in good condition with a well forested floodplain and wetland areas protecting the stream's stability. The reach is relatively undeveloped, or has returned to a largely undisturbed condition. There are a few low stream banks with evidence of minor erosion and a short section of undercut bank. There are a few short sections that appear slightly over wide, with one small central bar. Cross-Section

Figure 7.2.1 Typical scene in Management Unit 1 looking downstream located approximately 1,320 feet from Lake Utsayantha.

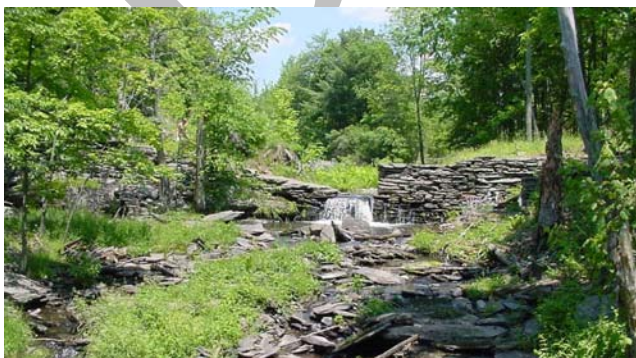
There is one small private bridge and an old dam at the bottom of the reach. The Lake Utsayantha dam, a bedrock outcrop just above the mill dam and the old mill dam provide grade controls through this reach (see **Figure 7.2.2**).

Figure 7.2.2 Remains of the old mill dam located approximately 375 feet upstream from River Street stone arch bridge.

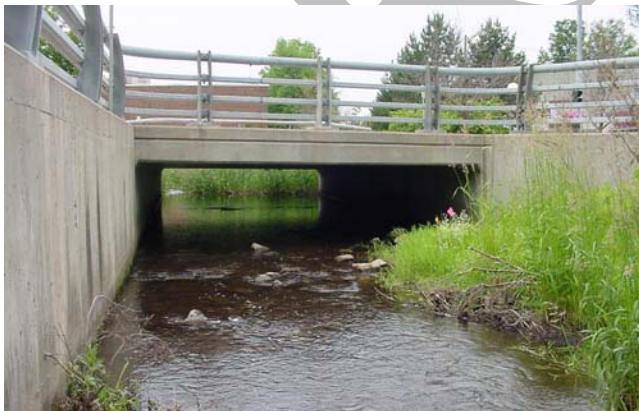
Figure 7.2.4 Looking downstream at NYS Route 23 Bridge.

Other private driveway bridges/culverts allow driveways to cross the channel through this reach before the channel becomes revetted for the last 300 ft before crossing under NYS Route 23 (**Figure 7.2.4**). The landowners living along this section of the river have been plagued with flooding, but the river's low slope and the intensity of land use through this 1700 foot reach provide few options for alleviating this condition. Reestablishment of a limited floodplain (converting the channel from an F to an entrenched E channel) may provide some relief, but would require that landowners along the stream be willing to move their activities away from the channel.

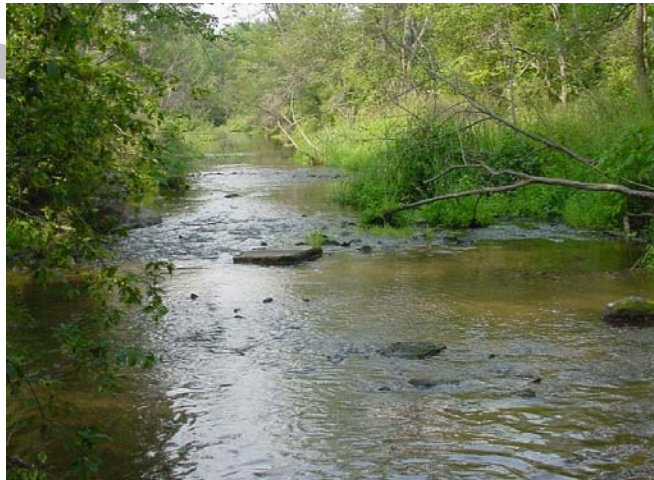
Figure 7.3.1 Typical scene in Management Unit 5 located approximately 3,500 feet upstream from Basset Brook Confluence.

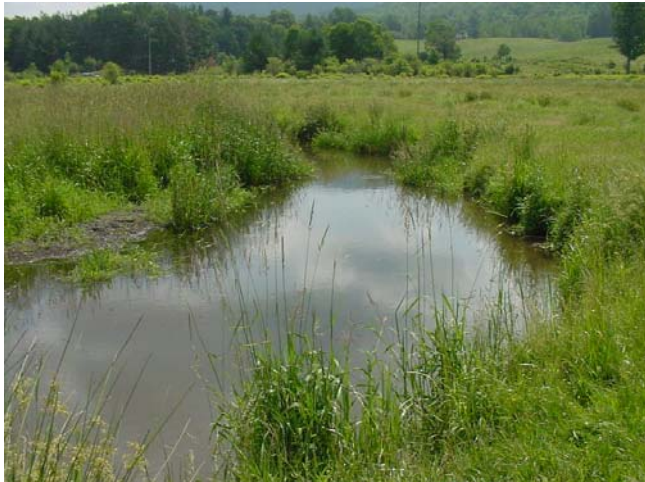
Figure 7.3.2 C6c- stream type that is located at the top of management unit 5 downstream of bridge.

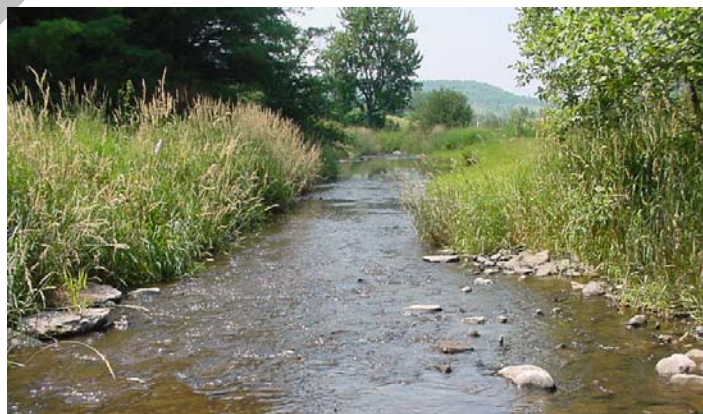
Figure 7.3.3 Typical scene of the river located at the top of management unit 6.

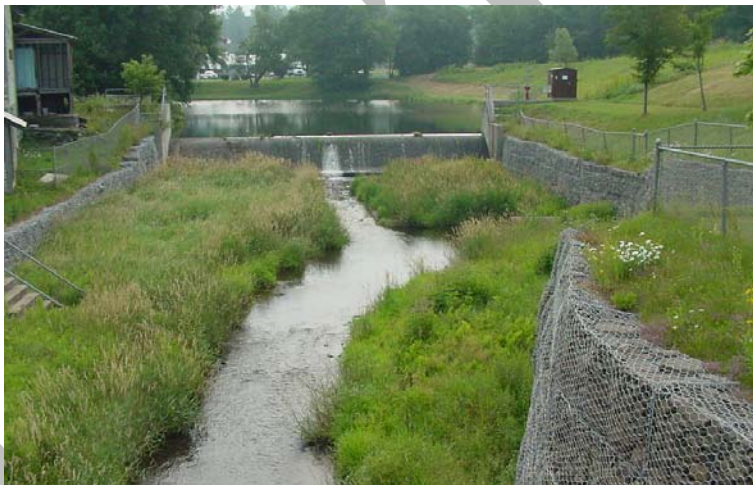
Figure 7.3.4 Looking upstream at one of the dams in Hobart from Maple Avenue Bridge.

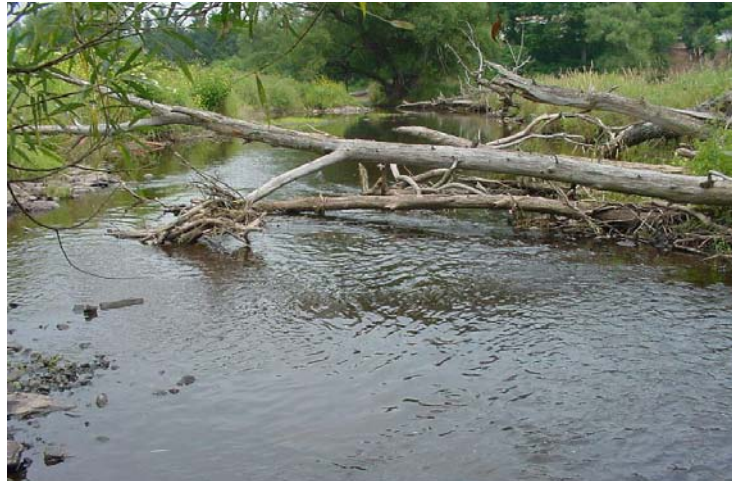
Figure 7.3.5 Looking downstream at a long, shallow, overly wide pool just upstream of Town Brook confluence.

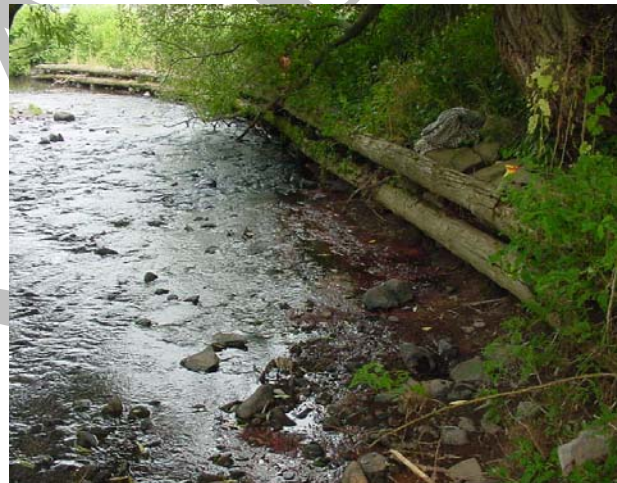
of Environmental Conservation structures are found in this reach, including log cribbing, log deflectors and fish habitat structures. **Figure 7.3.8** shows log cribbing along the right bank. Bank erosion is common at the downstream ends of these revetments. There was over 2100 feet of bank erosion along this 10,500 foot reach. Over 50% of this eroded bank length had an average bank height of 4.5 feet or greater.

Figure 7.3.8 Log cribwall on the right bank located approximately 1,200 feet downstream from Town Brook confluence.

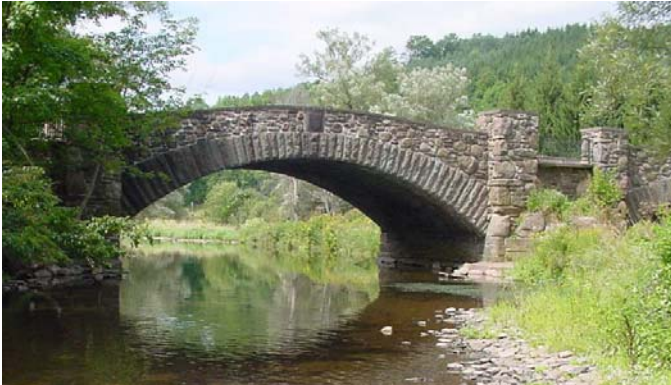
Figure 7.3.12 Looking downstream at County Bridge 18-6.

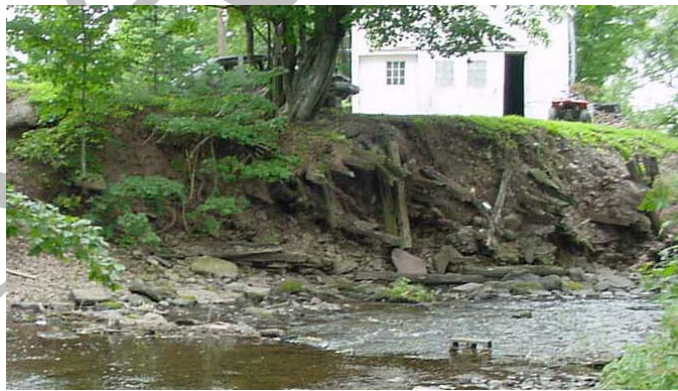
Figure 7.3.13 Looking downstream at an eroding bank located approximately 1,750 feet upstream from County Bridge 18-6.

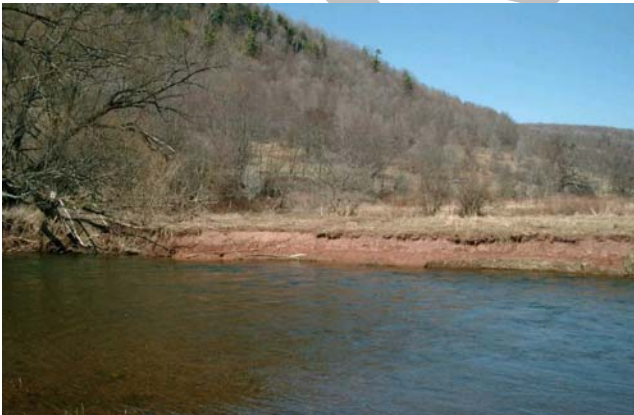
Figure 7.3. 15 An eroding bank downstream of railroad bridge where bank pin #34.3 is located.

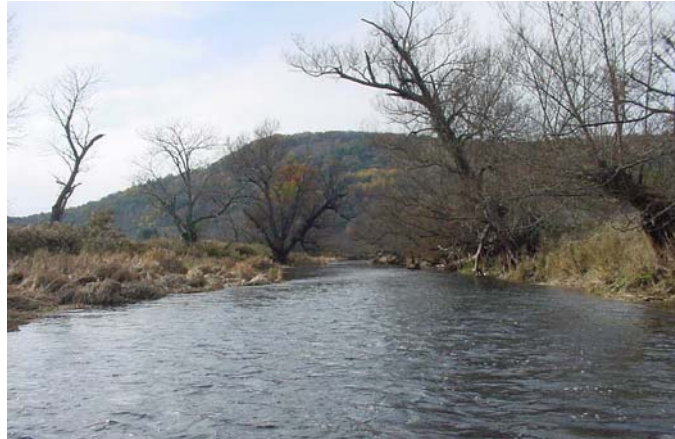
Figure 7.4.1 Typical scene in Management Unit 14 located approximately 6,500 feet downstream from County Bridge 33.

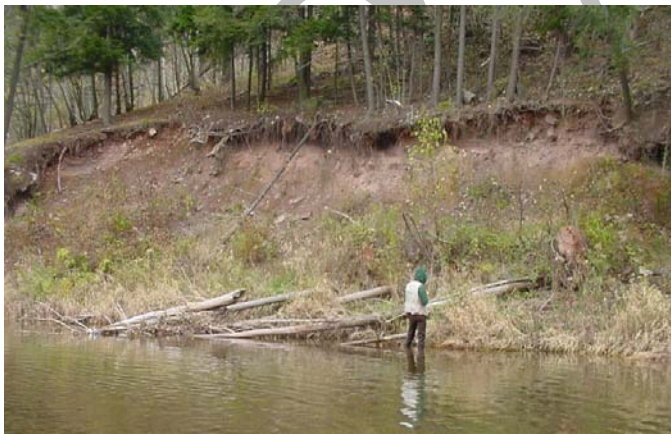
Figure 7.4.2 High eroding right bank located approximately 2,600 feet upstream from County Bridge 33.

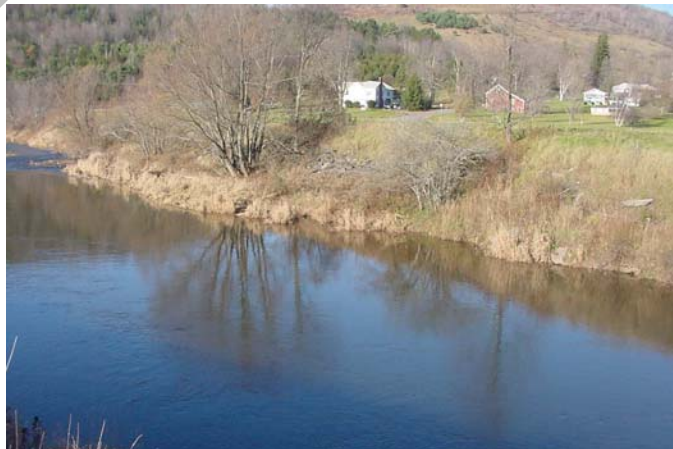
Figure 7.4.4 Typical scene in Management Unit 15 near the Elk Creek tributary.

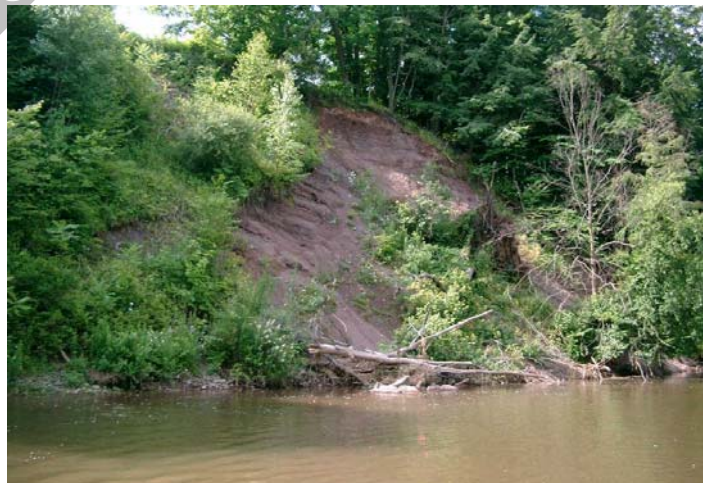
Figure 7.4.6 High eroding bank on the left side of the river near the top of this management unit.

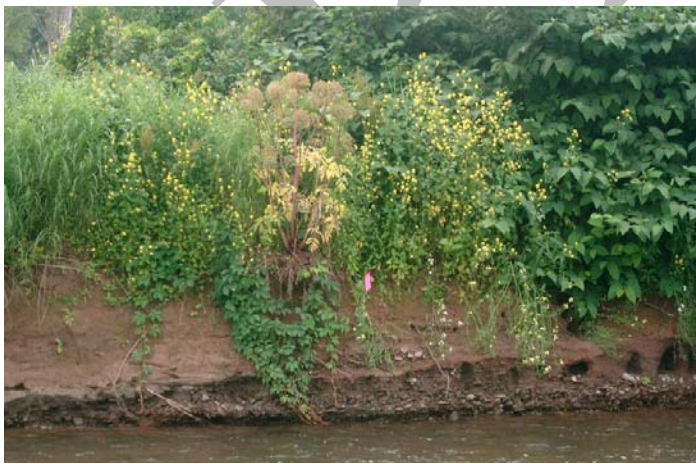
Figure 7.4.10 Poorly vegetated bank and a section of Japanese knotweed located approximately 2,000 feet upstream from County Bridge 10.

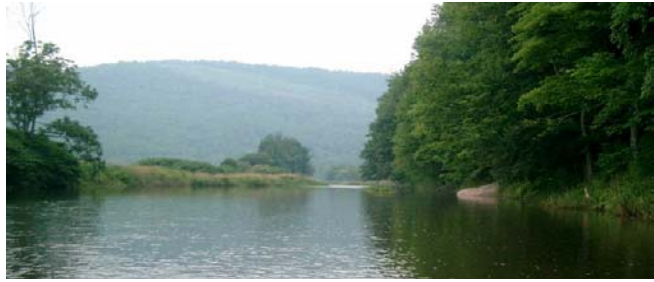
Figure 7.4.11 Typical scene in Management Unit 19 located downstream of County Bridge 10.

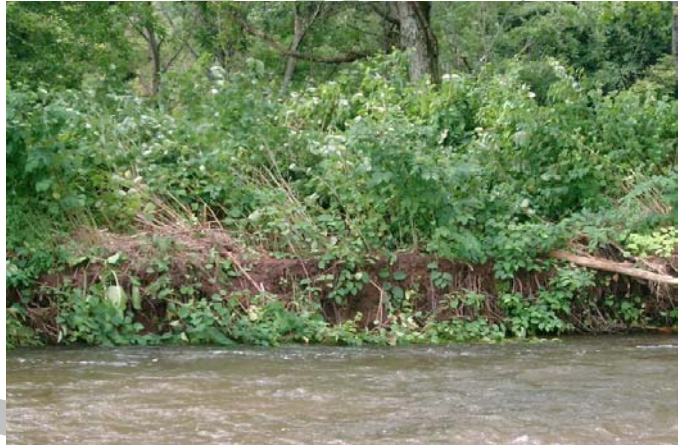
Figure 7.4.12 Section of Japanese knotweed and eroding bank found near the Delhi college agricultural land.

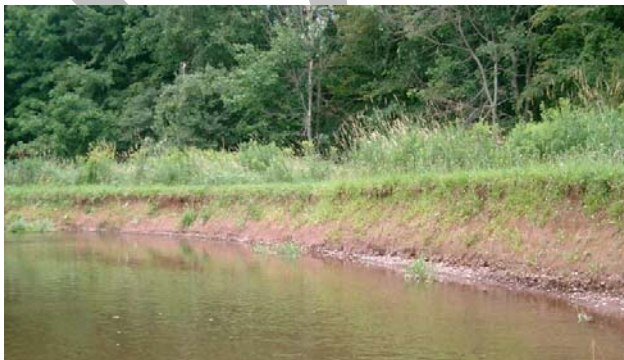
Figure 7.4.13 Poorly vegetated eroding bank located upstream from Peaks Brook confluence.

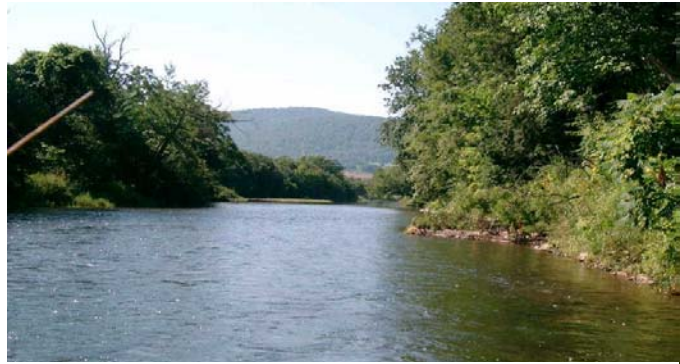
Figure 7.5.2 Typical scene of the West Branch in Management Unit 21 located approximately 4,000 feet upstream from Bagley Brook confluence.

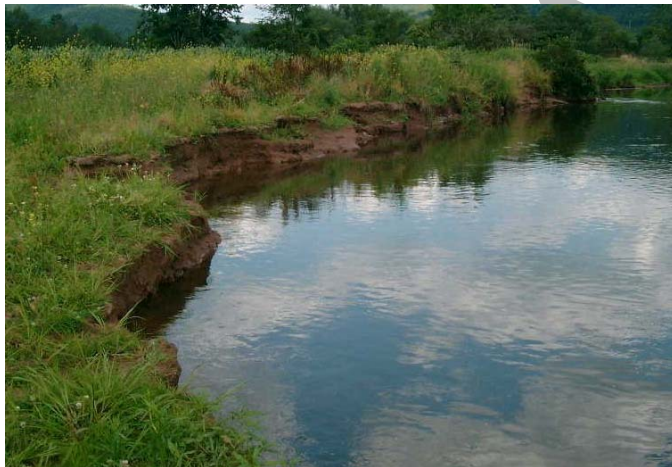
Figure 7.5.3 Eroding bank upstream from Bagley Brook confluence.

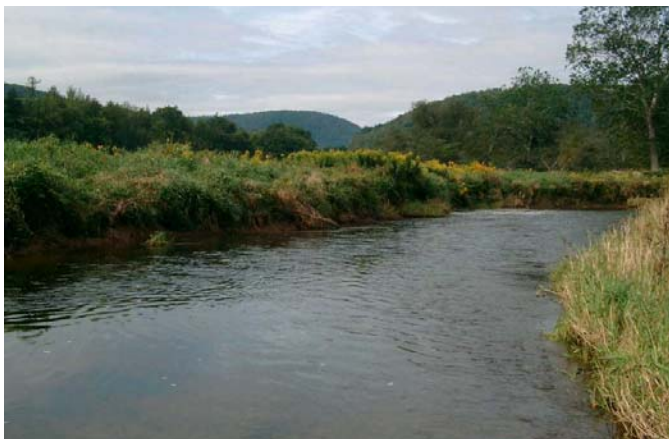
Figure 7.5.10 Poorly vegetated bank that is easily eroded on the island.

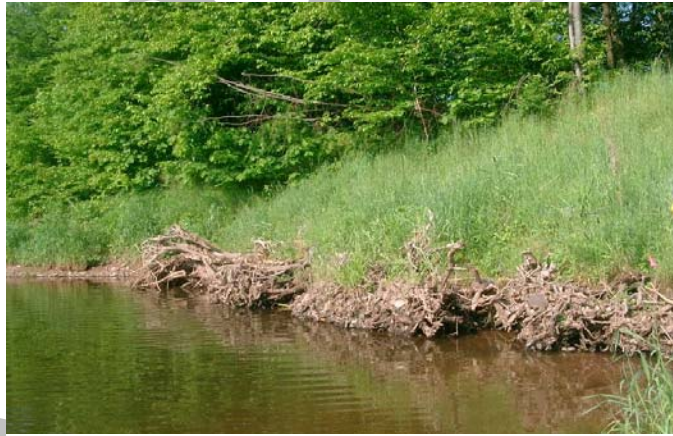
Figure 7.6.2 Root wad revetment that is located near the Delaware County Solid Waste Management Center.

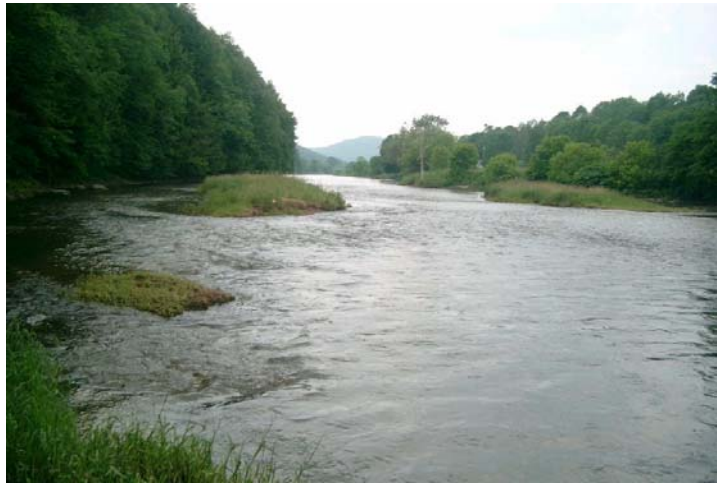
Figure 7.6.4 Typical scene in Management Unit 27 looking downstream at the top of this management unit.
