5.1 REGIONAL SETTING ..... 2

5.8 HYDROLOGY ..... 13

5.9 INTRODUCTION TO STREAM PROCESSES ..... 23

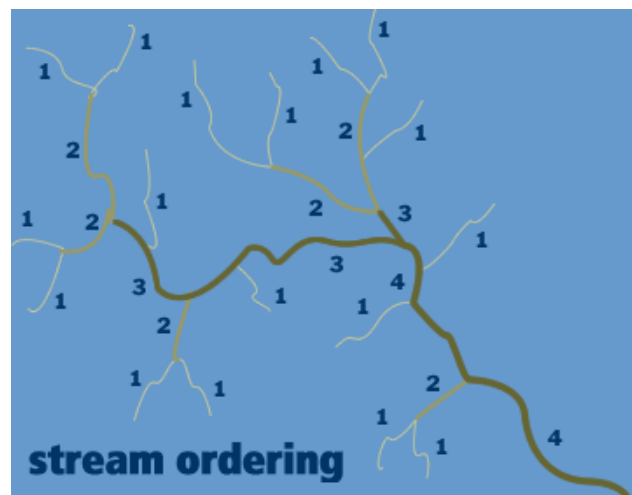
Streams in the West Branch basin form a connected system that can be classified by “stream order”. Stream order identifies the position in a hierarchy of tributaries occupied

**Figure 5.4** Stream Ordering (NRCS)

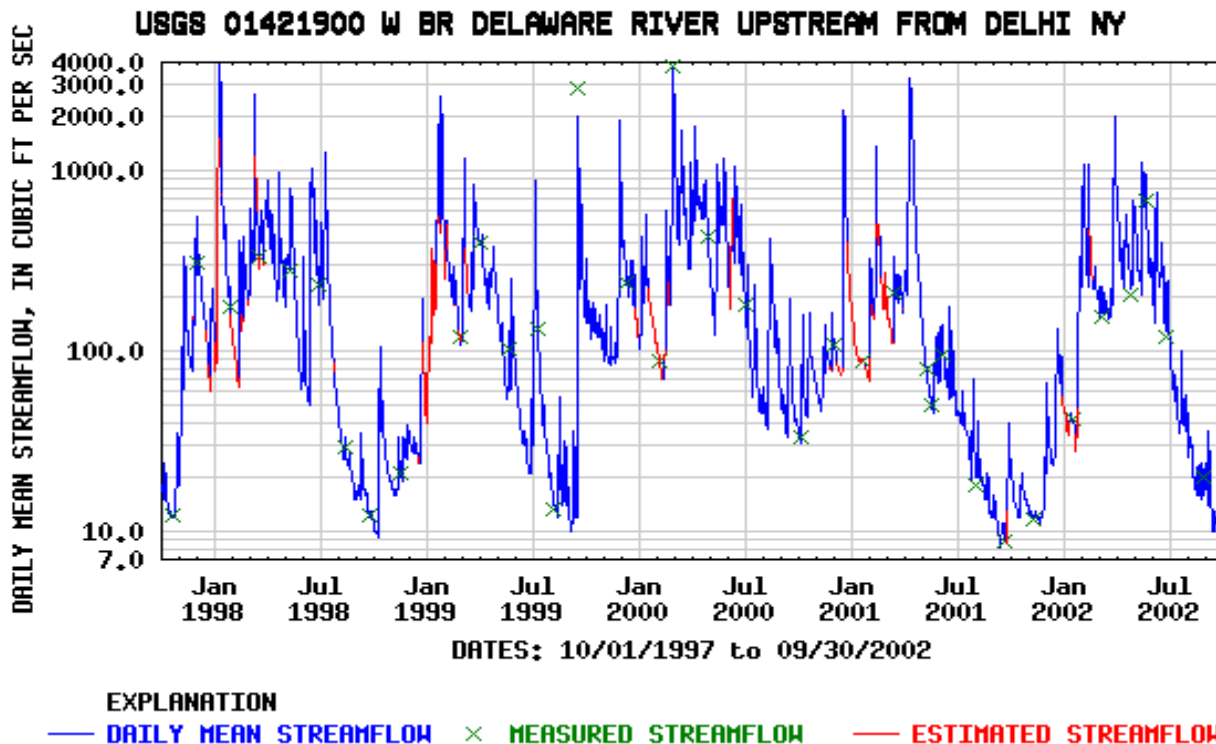
We can also analyze longer time periods to see seasonal trends or long-term averages for any given period when the gage was in service. The record for the gage upstream from Delhi (**Figure 5.6**, below) shows higher flows in fall (hurricane season) compared to winter (when water is held in ice and snow), and higher flows in spring (snow and ice melt) compared to summer (drier conditions, with vegetation removing a lot of water). The highest flows of the year are generally associated with spring snowmelt. A spike from the July 4, 1999 storm is also noticeable.

Figure 5.6 Hydrograph for a five-year period from the USGS Station upstream from Delhi, water years 1998 through 2002.

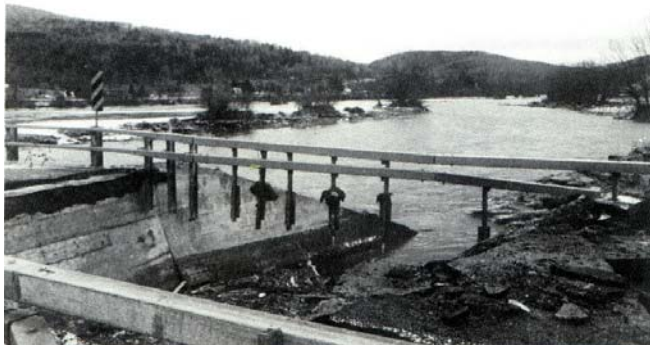
**Figure 5.9** West Branch of the Delaware River looking upstream from County Bridge on County Route 2 in Delancey, January 1996

Occasionally, a widespread storm/snow melt event results in a flow with a higher recurrence interval flood at upstream gaging stations than at the Walton station, such as happened in January 1996. This is probably due to flows from downstream tributaries, peaking and flushing through the system before water from upstream sources reaches the Walton station.

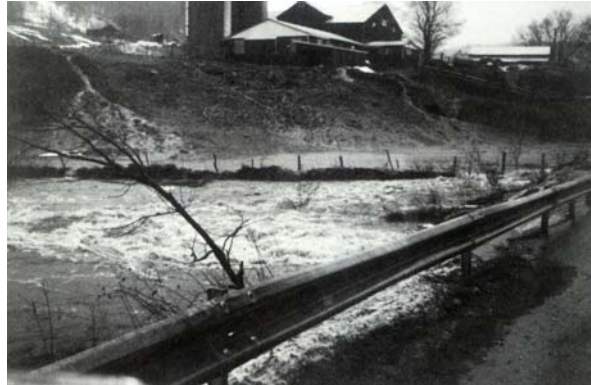
**Figure 5.10** East Brook near the former Pierce farm, January 19, 1996

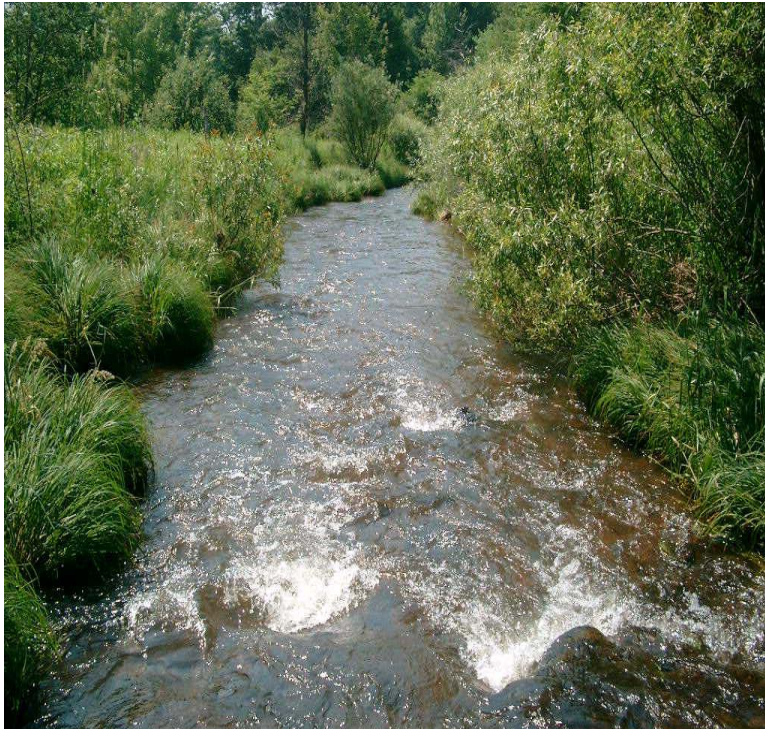
Town Brook reference reach.

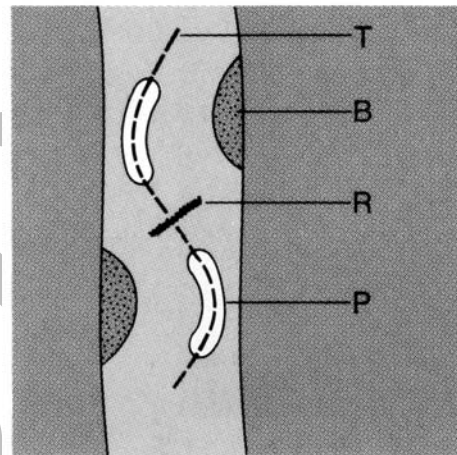
The following figure (Ritter 1978) shows these same features in a straight channel. The pool-pool spacing of a straight channel approximates the pool-pool spacing of a meandering channel.

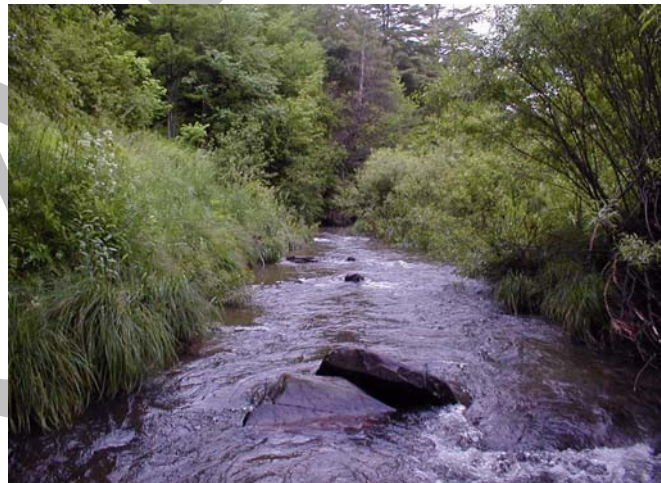
**Figure 5.19** A healthy riparian community is densely vegetated, has a diverse age structure and is composed of plants that can resist disturbance. View of Town Brook Reference Reach.

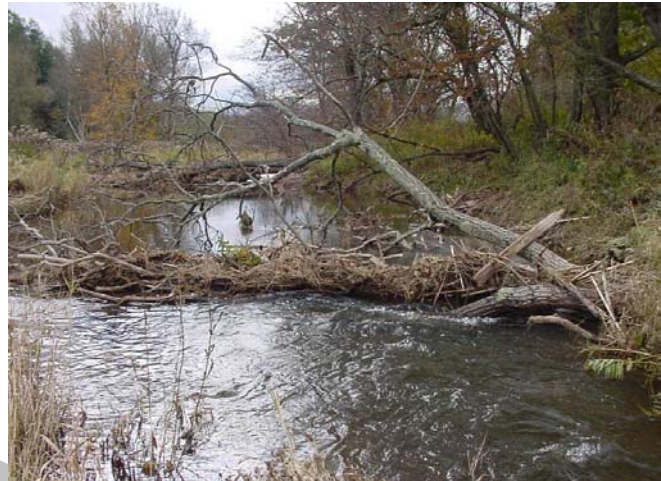
**Figure 5.20** A channel-wide debris jam.

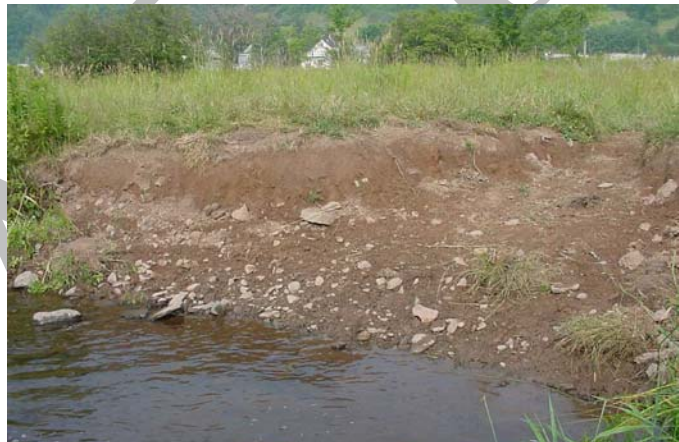
Continuous access to streams by livestock has a significant impact on the vigor, mortality and diversity of riparian vegetation. Grazing can reach an intensity that keeps grasses and forbs at a height too low to effectively uptake nutrients and impede storm runoff, which increases environmental contamination and streambank erosion. Intensive riparian grazing also inhibits the growth, establishment and/or regeneration of shrubs and trees while hoof shear (cattle-eroded stream access points) on streambanks exacerbates erosion. Cultivating row crops and mowing haylands to the stream's edge or the top of the streambank also result in decreased species diversity and riparian buffer width. These practices significantly increase runoff and associated nutrient contamination and erosion.

**Figure 5.21** View of streambank significantly impacted by cattle activity.

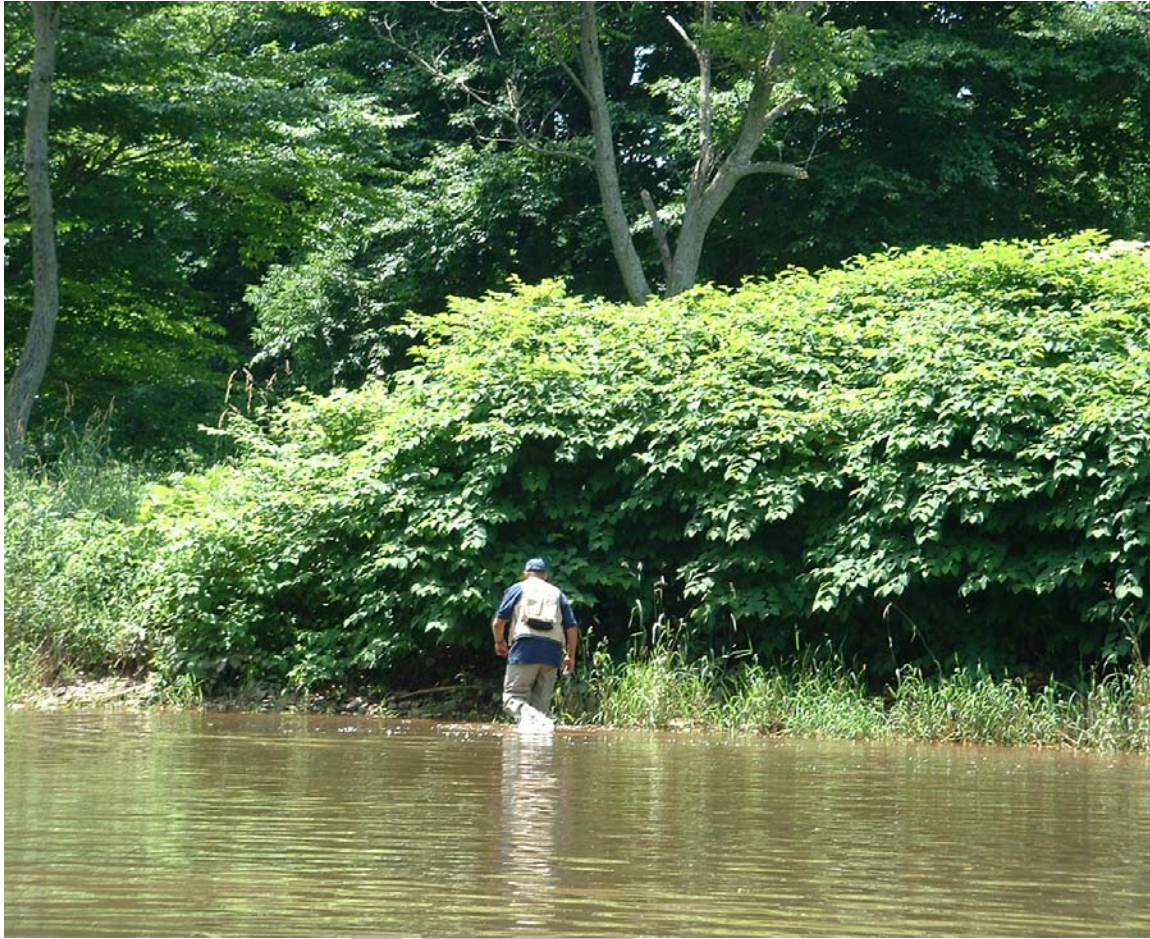
**Figure 5.22** Japanese knotweed along the West Branch of the Delaware, summer 2003

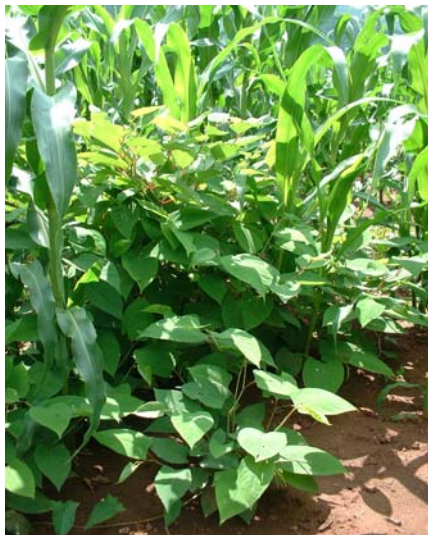
**Figure 5.23** A farmer in the Batavia Kill valley explained how a tractor barely caught a knotweed stem and pulled it into his cornfield and now it's growing amongst the corn.

Knotweed spreads vegetatively from portions of the roots or shoots. This vegetative propagation characteristic explains how it has expanded into such a wide variety of environments. The rhizomes begin new colonies of knotweed by spreading up to 20 feet from an existing plant. For this reason people may transport knotweed unknowingly by digging up rhizome-contaminated soils and dumping them elsewhere. Even a very small piece of this rhizome can sprout a new plant.

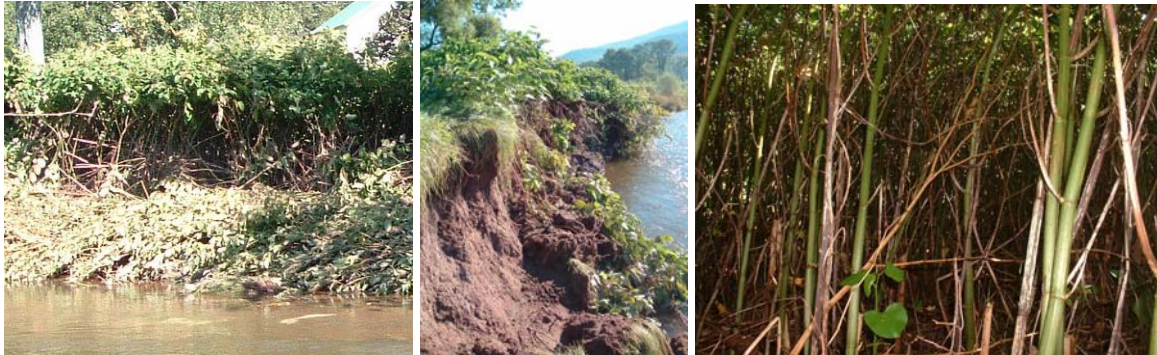
**Figure 5.24** From left to right: knotweed flattened by high flow event in Greene County, a stream bank slump where only grass and knotweed bordered streambank, and the shade created by dense canopy of broad knotweed leaves.
