Section 7 – West Branch of the Delaware River Stream Segments and Management Units
 January 10, 2005

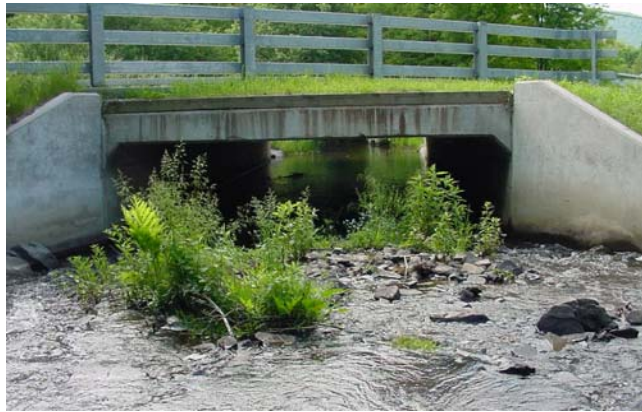
Figure 7.2.3 Deposition at the upstream end of the box culvert located on River Street.

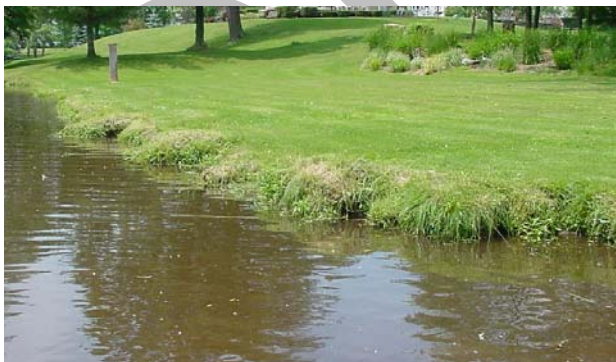
Figure 7.2.6 Lawn maintained to edge of water located approximately 350 feet upstream from Railroad Avenue culvert.

After passing under the rail trail bridge, the stream returns to a C stream type although the flat slope of the stream is maintained by a small dam at the end of a long pool just upstream from the culvert on Railroad Avenue. In this reach, the riparian buffer on the right bank is weakened by the maintenance of a lawn up to the edge of the water (see **Figure 7.2.6**). Integration of shrubs and a few trees would increase bank stability and help ensure that the river does not circumvent the check dam above the Railroad Avenue culvert.

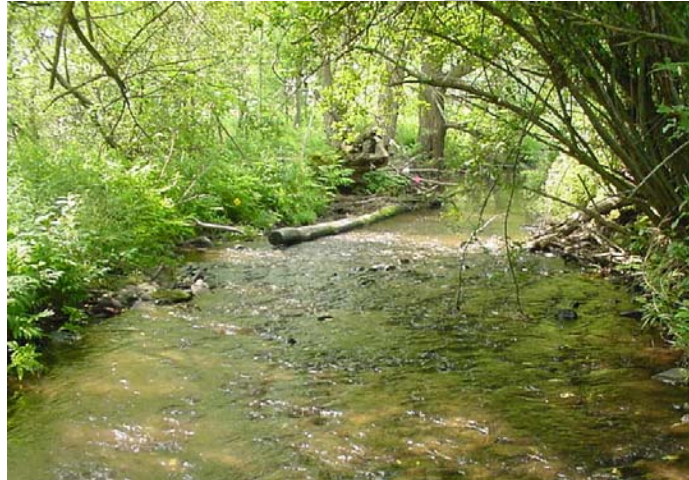
Figure 7.2.7 Typical scene in Management Unit 4 looking downstream located approximately 160 feet upstream from Axtell Road.

and rip rap. Also, the stream may have been realigned sometime between 1971 and 1983. This realignment may have been related to a previous aerator/settling tank upgrade to the treatment plant. The entire reach along the treatment plant shows evidence of instability with the frequent use of rip rap indicating the repeated need to strengthen the banks. Even the two residential properties at the end of Axtell Rd have had to rip rap their stream banks. Additional vegetation at key points along the stream bank would help improve the riparian buffer and reduce the need for rip rap maintenance. The stream type below the wetland changes from C4 to B4 and then back to a C4 at the bottom of the reach near the treatment plant outlet. The change is due to the rip rap placement which confines the stream and minimizes its access to a floodplain.

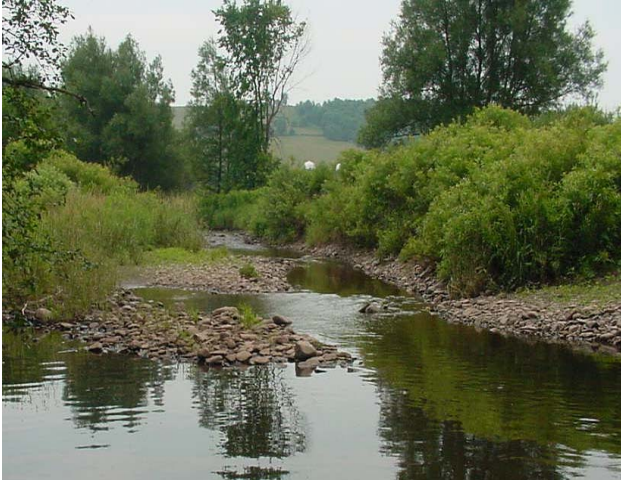
Figure 7.3.7 Looking upstream at the confluence of Town Brook.

Lake Brook, Town Brook and McMurdy Brook enter the main stem in this unit. The watershed area of the West Branch Delaware River more than doubles within this mile long reach. McMurdy Brook and Town Brook contribute a large amount of sediment load to the river. Aggradation features appear primarily in the upper half of this unit due to these three tributaries that enter the main stem.

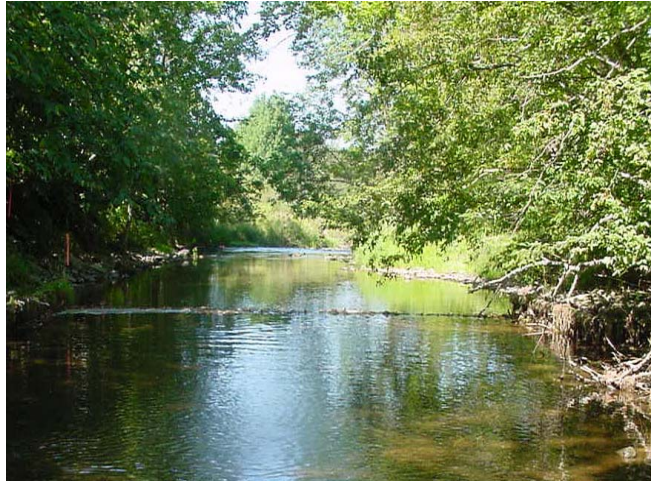
Figure 7.3.9 Typical scene in Management Unit 10 located downstream at a Department of Environmental Conservation pool digger located approximately 1,350 feet upstream of the Post private bridge near DEC fishing access parking lot.

The shallow rooted bank vegetation and the aggradation result in substantial bank erosion in the uppermost 2,000 feet of this unit. Of the 2500 feet of eroding bank in the entire management unit, 1500 feet occurs in the upper 2000 feet of the unit. As this reach is not entrenched, the average heights of these banks are generally less than 4.5 feet high. The remainder of this unit is largely bermed and rip rap. There is a significant amount of dumped stone on the banks which has been used to repair eroding sites. In the lower 4000 feet of the unit, the riparian buffer is less than 50 feet wide in most

places. As there are no Conservation Resource Enhancement Program sites in this area at this time, this reach should be a priority for CREP and other riparian buffer enhancement efforts.

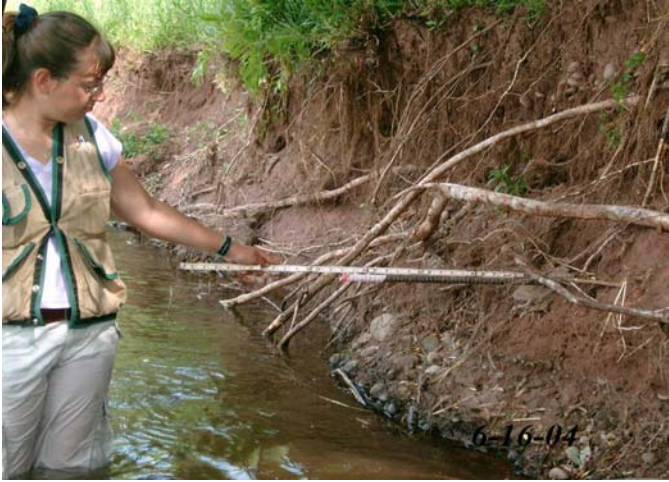
Figure 7.3.14 Monitor bank pin located in the eroding bank that is shown in the **Figure 7.3.15**.

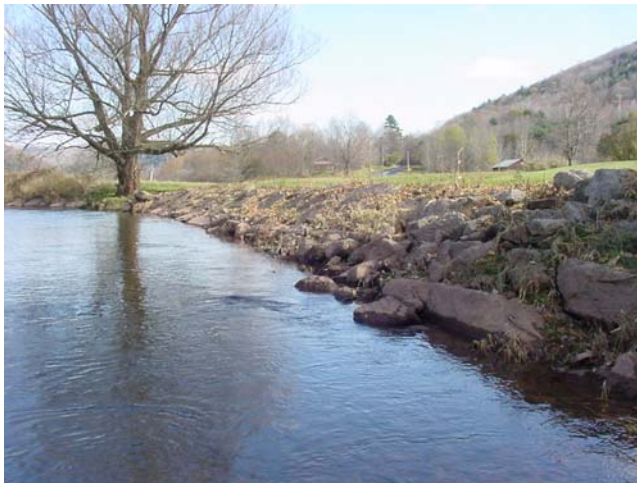
Figure 7.4.3 Typical rip rap installation approximately 1/2 mile upstream of County Bridge 94.

Revetments such as rip rap as shown in **Figure 7.4.3** are used to help protect the stream banks from erosion, but the excessive use of rip rap can accelerate the stream's *velocity* along the bank and result in additional erosion downstream.

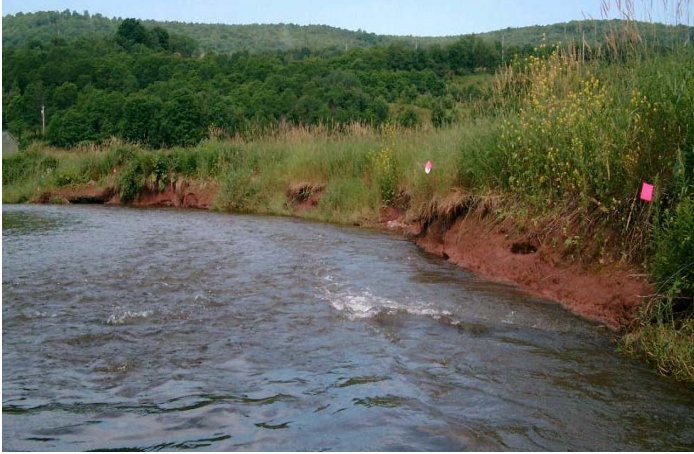
Figure 7.4.7 Poorly vegetated eroding bank on the right side approximately 100 feet downstream of **Figure 7.4.6**.

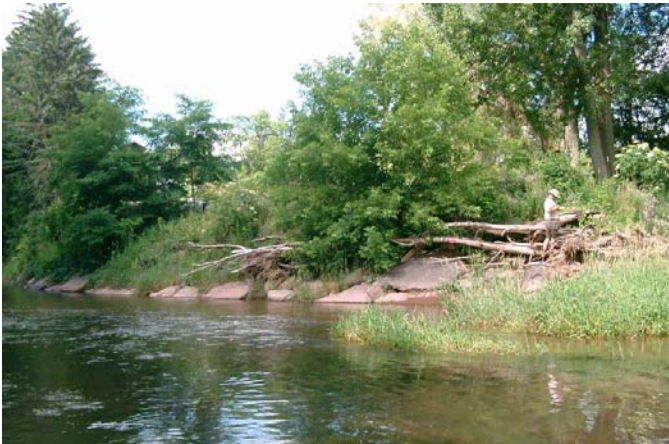
Figure 7.4.8 Rip rap along the island upstream from Kingston Street Bridge.

There are noticeably more revetments along the banks (3110 feet of revetment over 4500 feet of stream) and a decrease of eroding banks (1081 feet). **Figure 7.4.8** shows rip rap along the island upstream from Kingston Street Bridge.

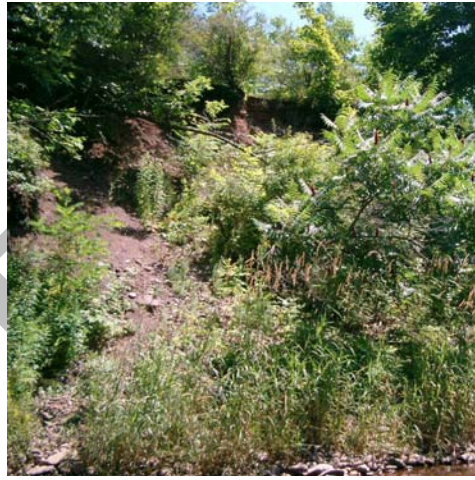
Steele Brook tributary contributes a high sediment load which is forming side, transverse and center bars downstream of its confluence. This excess sediment from Steele Brook is forming a center bar downstream of the outflow forcing the river toward the opposite bank. An old gage station was located just downstream of Steele Brook confluence and now the high bank is presently eroding as shown in **Figure 7.4.9**.

Figure 7.4.9 High eroding bank opposite of Steele Brook confluence.

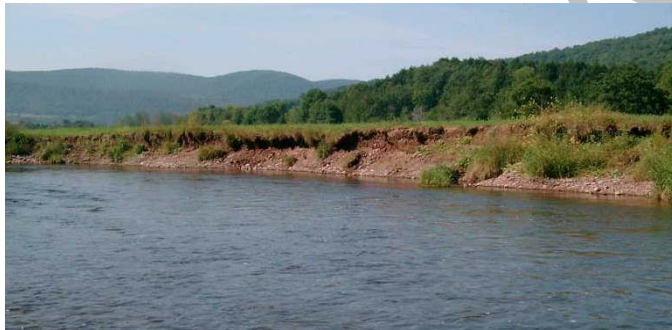
Figure 7.5.1 Typical eroding bank along agricultural field with no riparian buffer approximately 4,000 feet downstream of Platner Brook.

The significant number of eroding banks in the vicinity of aggradation areas suggests that the river is attempting to alter its alignment to enable it to move around the deposits. As many of these banks have little to no vegetation as shown in **Figure 7.5.1**, the river is able to rapidly remove huge sections of bank with each storm event. The riparian buffer width should be increased for almost all of the agricultural fields along the river in this management unit. The stream program should also continue to review

stable or “reference” stream alignments for large C streams in an effort to provide recommendations for channel realignment as needed by stream bank stabilization and river restoration efforts.

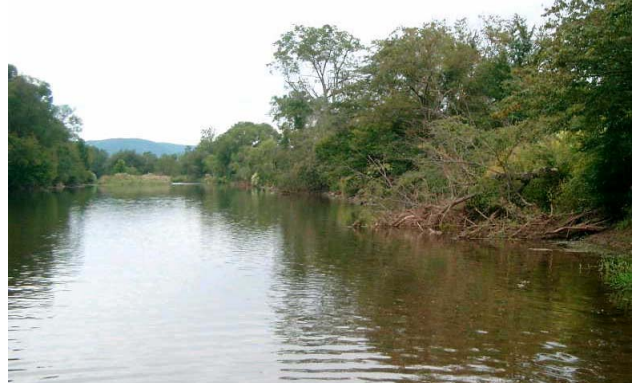
Figure 7.5.4 Typical scene in Management Unit 22 and is located 1,600 feet downstream from Launt

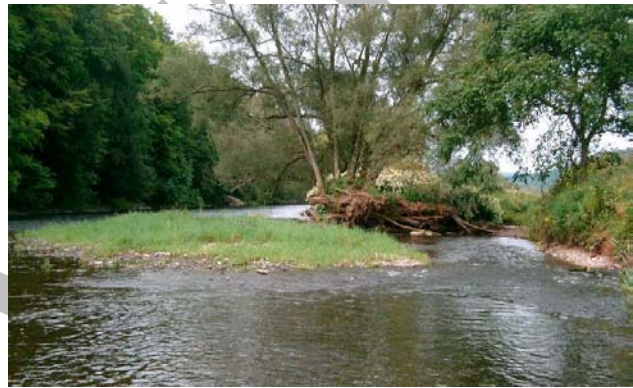
Figure 7.5.5 Confluence of Launt Hollow.

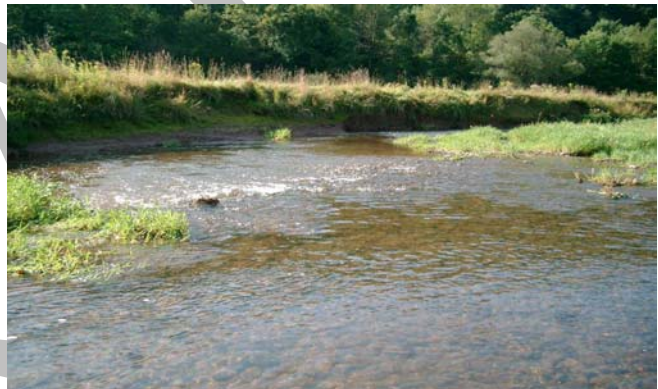
This area is primarily agricultural lands and there is a significant amount of erosion on poorly vegetated banks. **Figure 7.5.7** shows an eroding bank with poorly vegetated banks.

Figure 7.5.7 Poorly vegetated eroding bank that is associated with a transverse bar located 350 feet downstream of the confluence with Chambers Hollow.

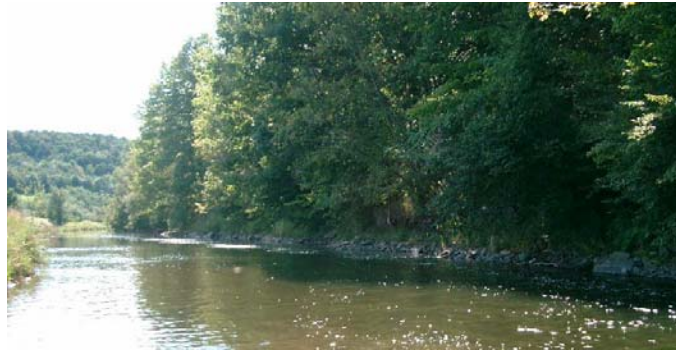
Figure 7.5.8 Typical scene in Management Unit 24 located 900 feet downstream of Mallory Brook confluence.

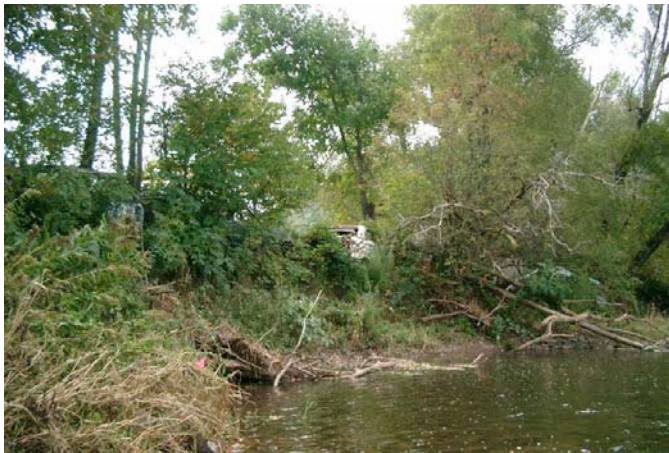
Figure 7.5.9 Vehicle revetment that is located approximately 7,400 feet downstream of County Bridge 26-6.

In the lower part of the unit there is a berm constructed of cars and school bus bodies along the left bank approximately 1,100 feet long which can be seen in **Figure 7.5.9**. This revetment is an ill-advised attempt to protect agricultural land during flooding events.

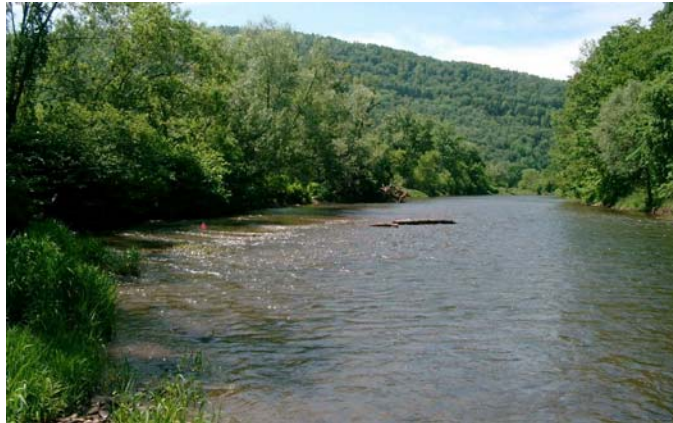
This management unit consists of lands that are mainly agricultural fields with some forested areas. Delaware County Solid Waste Management Center is located within this unit. Oxbow Hollow tributary enters the West Branch downstream of the waste management center. This management unit is considered to be stable. **Figure 7.6.1** is a picture taken within Management Unit 25.

Figure 7.6.1 Typical scene in Management Unit 25 located at the top of this unit.

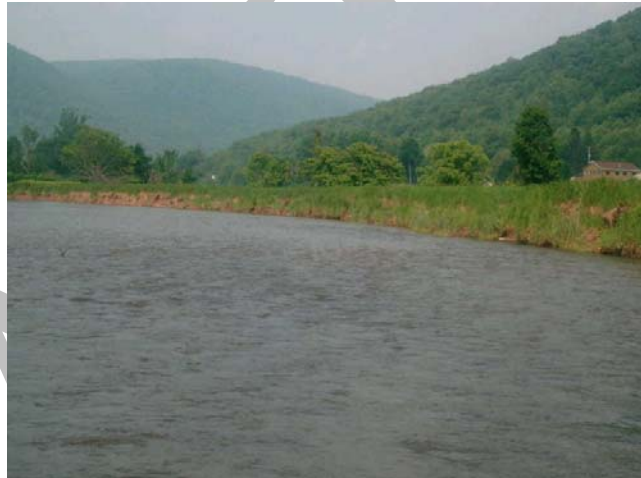
There is a total of 4,054 feet of eroding bank along this 8,545 foot long management unit. The height of the eroding banks varies from about 2 feet to about 8 feet, with about 30 percent of the eroding bank length having an average bank height of greater than 4 feet. It is likely that the stream banks in this management unit contribute a significant amount of sediment to the river.

Figure 7.6.3 Poorly vegetated right bank that is eroding located approximately 1,500 feet downstream from Bonnefond Road.

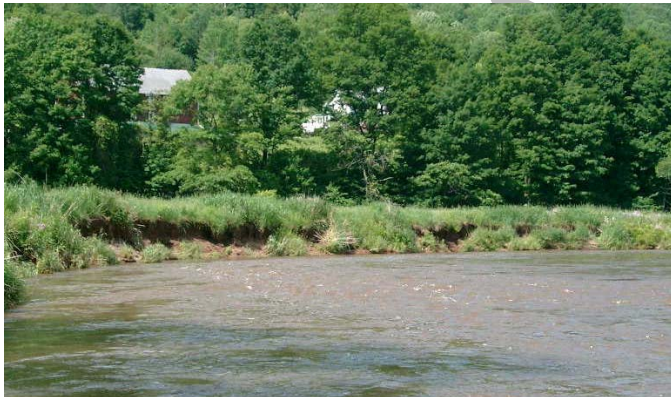
Figure 7.6.5 Poorly vegetated left eroding bank located approximately 1,500 feet upstream from Marvin Hollow confluence.

There are approximately 4,800 feet of eroding banks in this management unit. Eroded banks in this unit range from 1 to 8 feet in height, with nearly half of the eroding bank length (2,322 ft.) having an average bank height between 4' to 8' in height. The height of several of these eroding banks exceeds 10 feet.

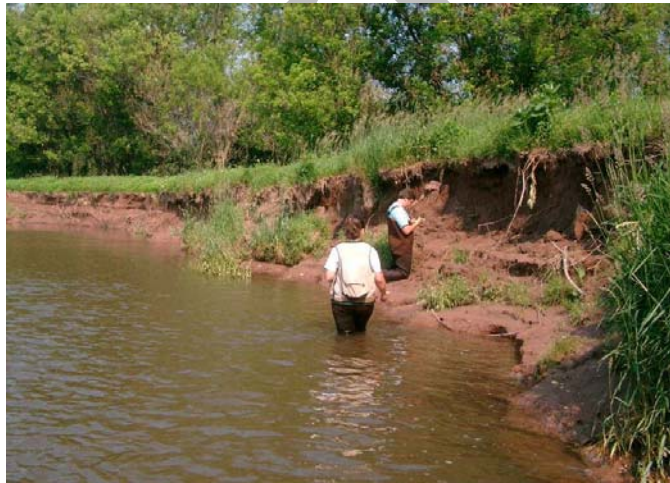
This unit has a higher than average number of depositional features. Most of these features are side bars and center bars. There is a 2,000 foot long section within this unit that consists of multiple channels. This same reach has severe erosion along its banks. At the very end of this unit there is a 4,000 foot long reach with a large number of depositional and erosional features concentrated together.

Figure 7.6.7 Poorly vegetated right bank located approximately 1,700 feet upstream from Pines Brook confluence.
